Drainage Complaint Analysis:

500 Glass Street-

City of City of Mount
Pleasant

Municipal Technical Advisory Service
INSTITUTE *for* PUBLIC SERVICE

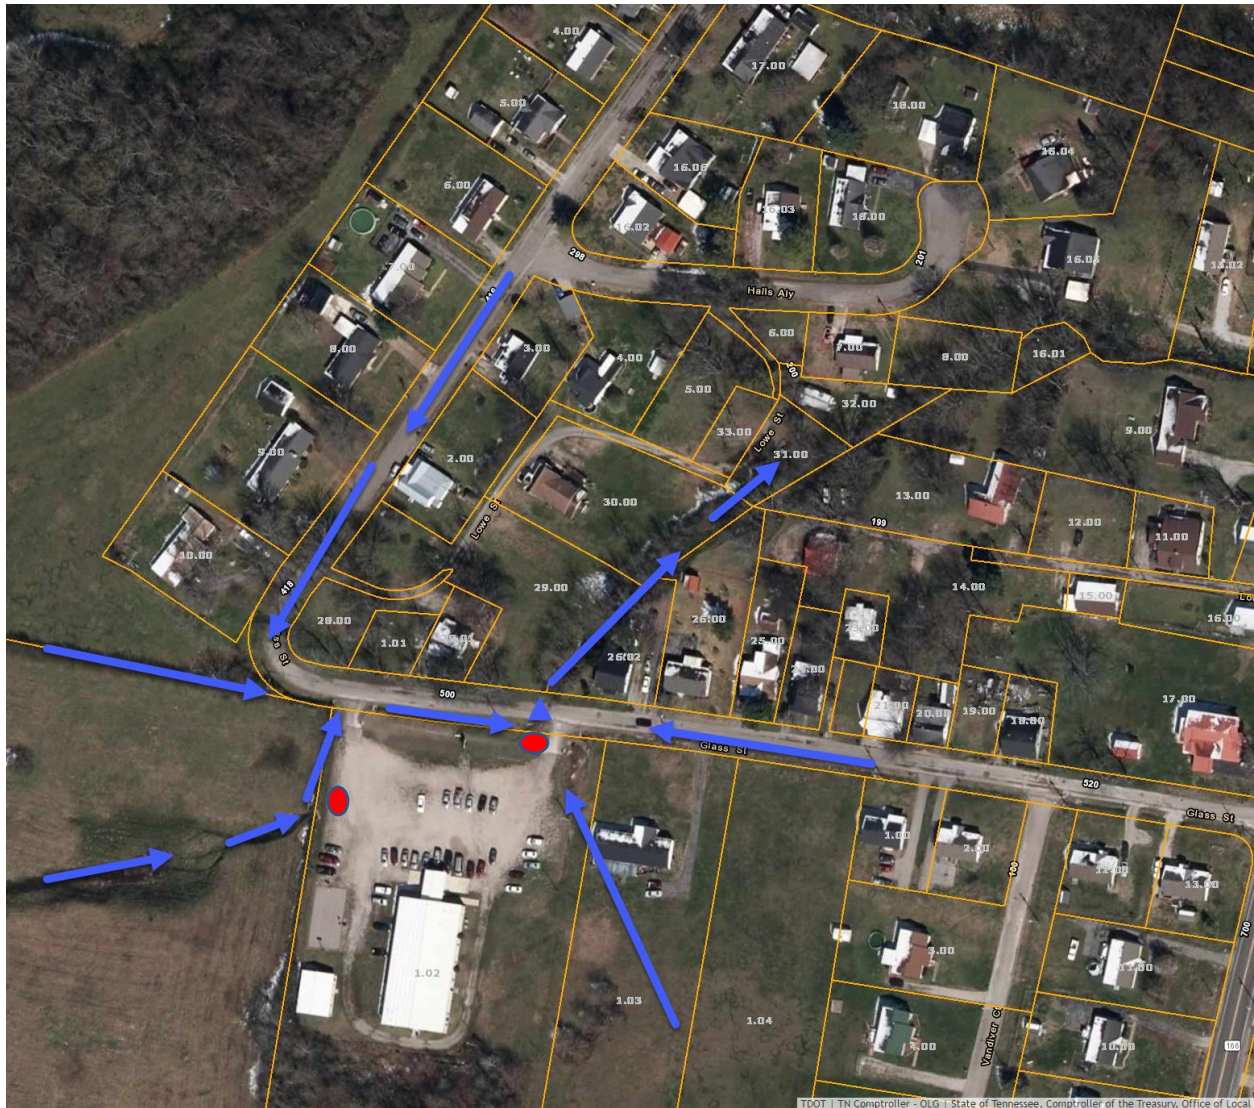
Pic. 1

The Church has two entrances on Glass Street. An aerial view of the location is provided in Pic. 1. The blue arrows generally depict the direction that drainage flows.

The two entrances that the Church maintains on Glass Street are shown in Pic. 1. The complaint, as I understand it, is that water that flows down the portion of Glass Street that runs roughly northeast to southwest, along with the other drainage from areas to the west and southwest, is overwhelming and scouring and eroding the west entrance to the property.

Now, as I understand further, the ditch that runs in a northeasterly direction until it reaches the western property line of the Church and turns north, used to continue across the Church property and connect the two red dots shown in Pic. 1. The portion of the ditch between the red dots was filled and the flow was subsequently diverted to the northwest corner of the property. When the ditch was in its original channel, the flow was carried under Glass Street in a large culvert and from there it continued in a ditch flowing in a northeasterly direction as shown in Pic. 1.

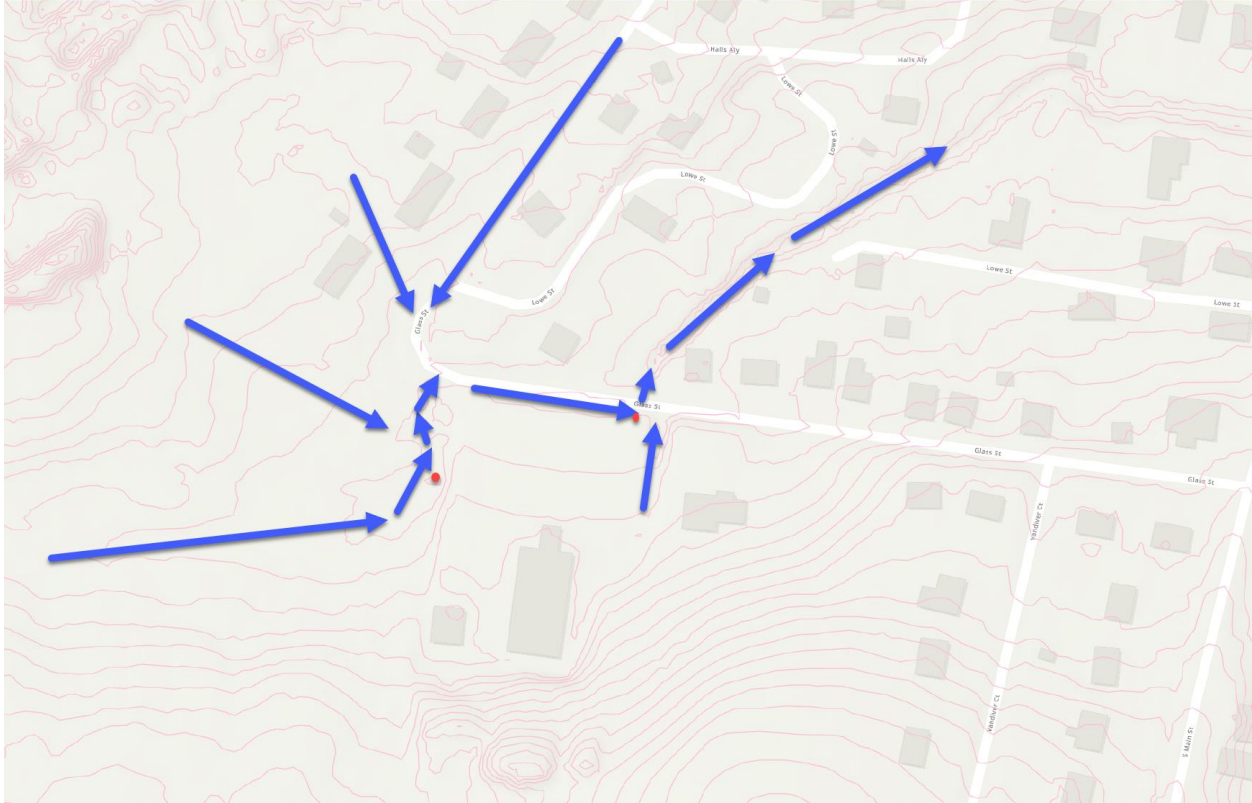
Pic. 2 provides a 2 foot contour map of the subject area and confirms the drainage patterns depicted in Pic. 1.

The arrows in Pic. 1 and Pic. 2 depict the flows that come from several directions to combine and then attempt to flow through the pipe beginning at the headwall on the west corner of the west entrance to the property. These combined flows flow through said culvert and, in the event of a large enough rainfall event, overflow the culvert, into a shallow swale running easterly on the south side of Glass Street in front of the Church. Please note that in Pic 5 the opening of the culvert is obscured by overgrown vegetation in the ditch that likely is also contributing to poor flow of the drainage system while serving as an impediment or partial obstruction during storm events.

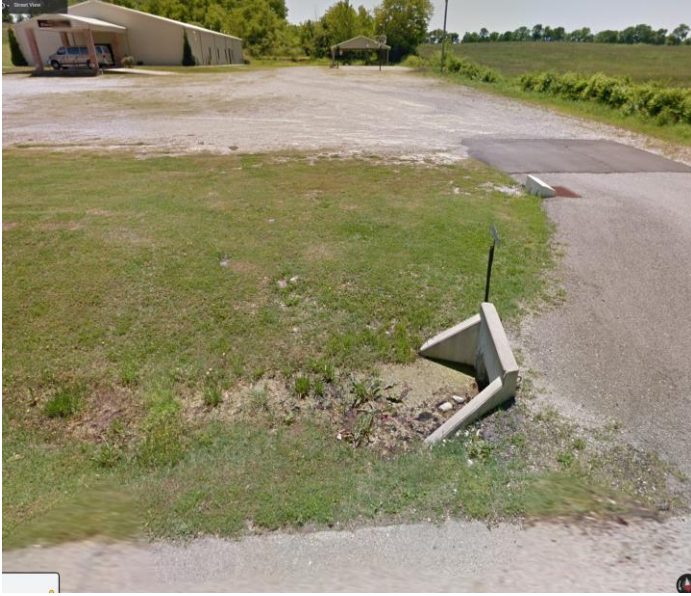
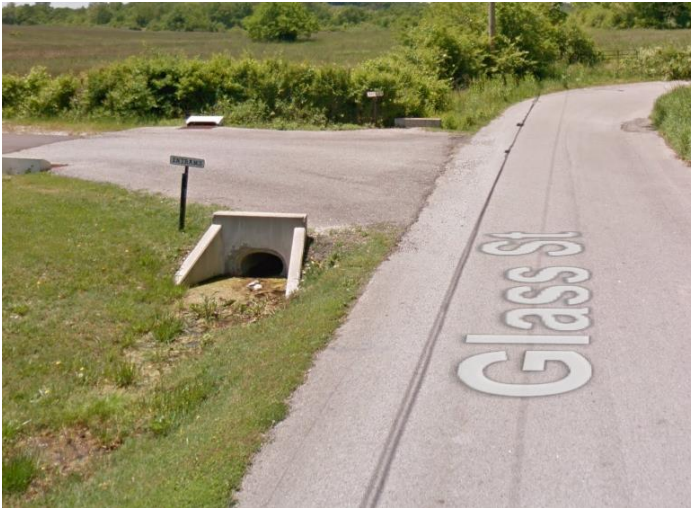
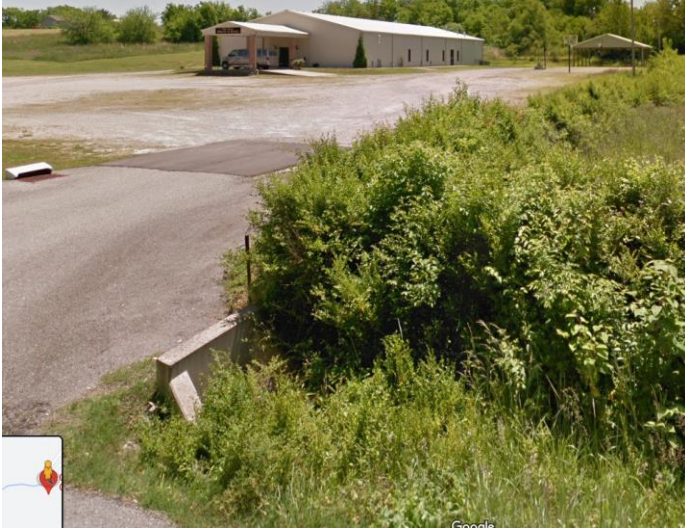
In Pic. 3, 4, and 5, the driveway culvert that replaced the large natural channel originally carrying drainage across the property to the large culvert running northeast under Glass Street is shown. In my professional opinion the driveway culvert shown is inadequate to meet the drainage requirements at this location.

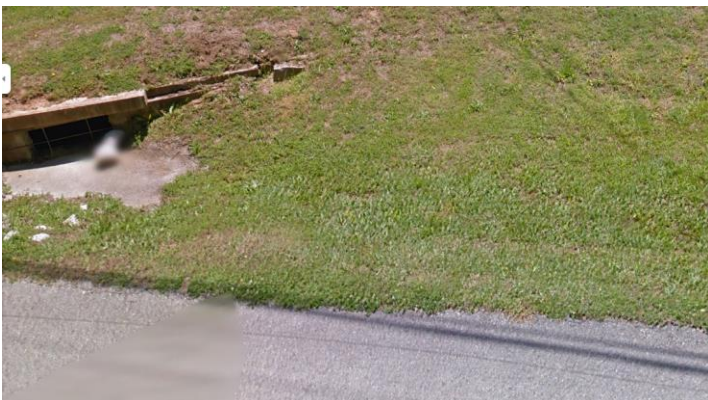
Pic. 6

The shallow swale terminates at the entrance (Pic. 6) to a structure that functions to drain the swale to its west, carry drainage under the east entrance to the property, drain a ditch on the east property line

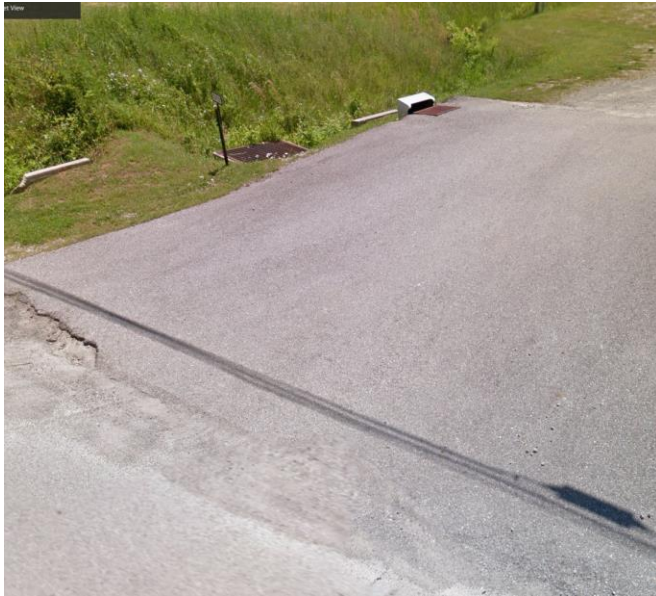
Pic. 7

(Pic. 7) of the Church and directs all of the drainage into the previously mentioned large culvert that runs under Glass Street at this point to connect with the ditch flowing in a northeasterly direction.
